# Manhole Inspection Summary

Manhole # S23E1\_015MH

Insp Date: **7/9/08 2:52 PM**

**Location** Address: **behind 2615 Pierpont St & southward** Cross Street: **Hollins Ferry Rd.**

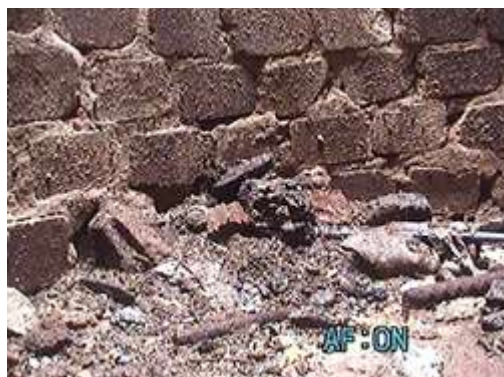
Defect 4

**Bench** ☒ Exists Material: **Brick** ☐ Parged  
Condition: ☐ Sound ☐ Cracked ☐ Root Intrusion ☐ Deteriorated ☐ Leaks ☒ **Debris**

Debris on the bench

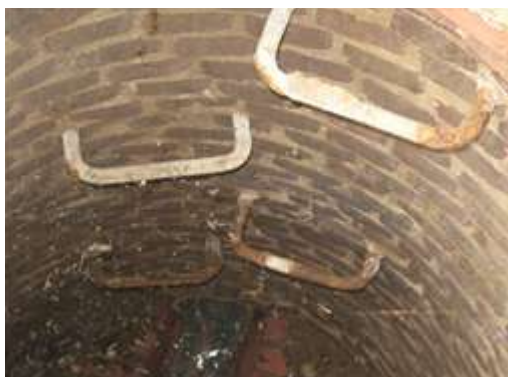
Defect 2

**Steps** Count: **4** Missing: **0** ☒ **Corroded**

Corroded steps

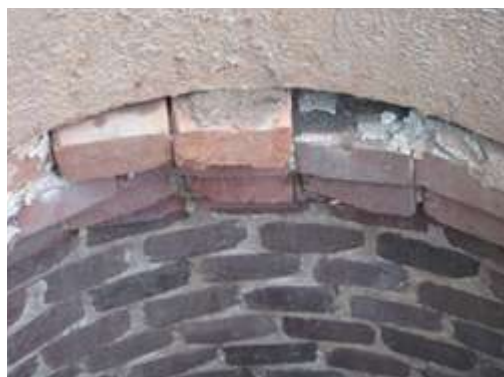
Defect 1

**Chimney / Frame Adjustment** ☒ Exists Material: **Brick** ☐ Parged Height: **10** (in.)  
Condition: ☐ Sound ☐ Cracked ☐ Root Intrusion ☐ Loose Brick ☒ **Deteriorated**  
Infiltration: ☐ None ☐ Joint ☐ Cracks ☒ **Mortar** ☐ Roots ☒ **Wall**

Chimney has loose brick and is deteriorated with infiltration from mortar & wall

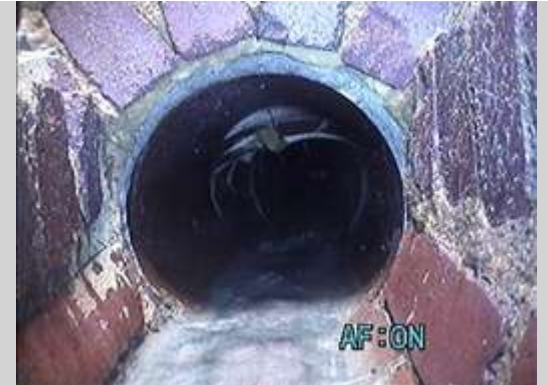
12 O'Clock Outflow

8 in. Circular Gravity Sewer  
Pipe Out @ 12 O'Clock

Pipe Height: **8.4** (in.) Rod and Bar (Angled)  
Pipe Material: **Clay** ☐ Pipe Lined  
Invert Depth: **8.81** (ft.) Flow Characteristics: **Slow**  
Deposits: ☒ None ☐ Mud ☐ Sludge ☐ Debris ☐ Grease  
Silt Depth: **0** (in.) Deposits Extent:  
Infiltration: **None** Pipe Seal Cond: **Sound**

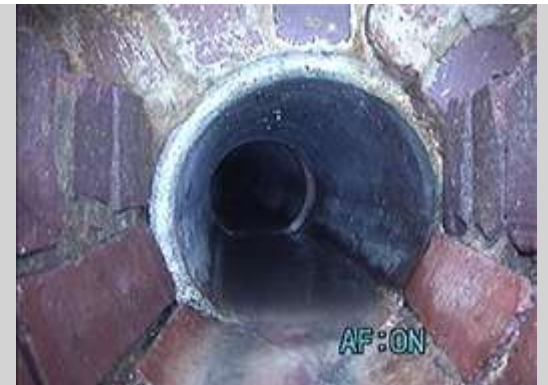
4 O'Clock Inflow

8 in. Circular Gravity Sewer  
Pipe In @ 4 O'Clock

Pipe Height: **8.4** (in.) Rod and Bar (Angled)  
Pipe Material: **Clay** ☐ Pipe Lined  
Invert Depth: **8.66** (ft.) Flow Characteristics: **Slow**  
Deposits: ☒ None ☐ Mud ☐ Sludge ☐ Debris ☐ Grease  
Silt Depth: **0** (in.) Deposits Extent:  
Infiltration: **None** Pipe Seal Cond: **Sound**

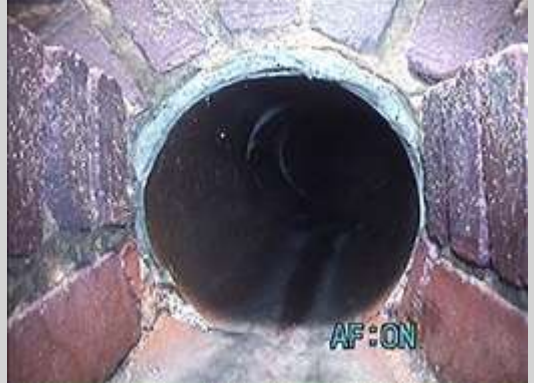
6 O'Clock Inflow

Infiltration: **None** Pipe Seal Cond: **Sound**
